Swagelining Renews Potable Water Transmission Lines

By Daniel F. Moore, P.E., Water Systems Engineer, Water and Sewer Department, City of Greeley, CO

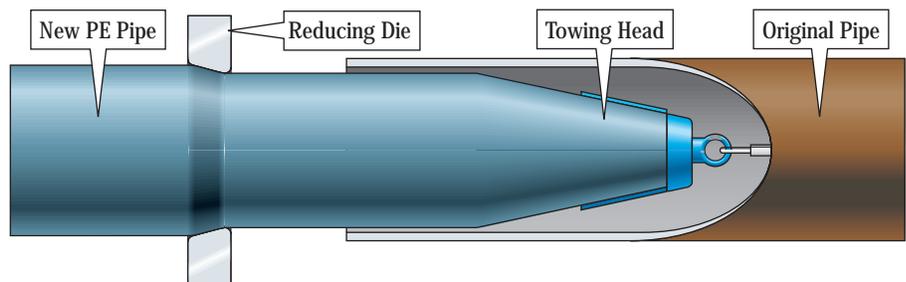
The PE pipe is reduced slightly during the installation process. This allows it to be pulled easily through an existing pipeline. Within a short time after installation, the PE attempts to return to its original size and presses tightly against the inside of the original pipeline.
