Project Impactor: On Location

On Line Pipe Replacement in Centerville, Iowa

Contractors	Jackson Creek Enterprises
Date	19-Feb-02
Project	Sanitary sewer main replacement, Centerville, Iowa
Specifications	340' of 10" clay tile replaced with 10" SDR 17 HDPE
Equipment	HammerHead 8" Air Impactor with expander for pulling in 10" HDPE and Vermeer® Navigator® D33x44 Horizontal Directional Drill

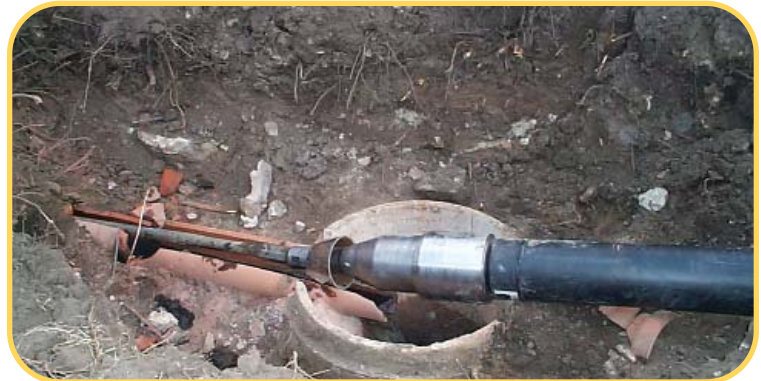
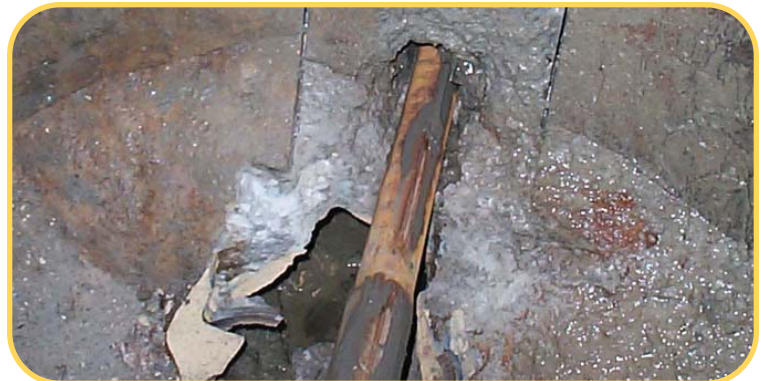
The next day David's crew attempted the burst again but success wasn't in the cards. The temperature was well below freezing causing ice to form in the Impactor, allowing it to cycle but not impact. Additionally, a brass washer and screw and pieces of a nylon bushing from the safety shut off valve on the air compressor broke free and traveled down the drill rod and into the Impactor. The resulting damage could not be repaired on site.

Once the damage from the foreign matter was repaired the design team reproduced the freezing effect in a test fixture. The introduction of isopropyl alcohol eliminated the effect of ice accumulation. Some modifications were made to the air flow paths and pneumatics allowing the Impactor to function in freezing conditions even with slight accumulations of ice.

1. Try not to burst with flow in a sewer line.
2. Always clean drill rods by blowing air and water through them prior to attaching to the Impactor.
3. Murphy was an optimist.
