New Orleans, Louisiana
March 22-24, 2004

WATER DISTRIBUTION SYSTEM REPLACEMENT UTILIZING PRE-CHLORINATED PIPE BURSTING TECHNOLOGY TO PROTECT SENSITIVE ENVIRONMENTAL AREAS

The National Park Service (NPS) engaged CDM to design and construct improvements to its Flamingo water system, including the complete replacement of its water distribution system. The Flamingo area is the largest developed area within Everglades National Park (Park) and includes a visitor's center, restaurant facilities, and housing to accommodate visitors from all over the world. The existing water distribution system consists of 25,000 linear feet of 6-, 4-, and 2-inch asbestos concrete and polyvinyl chloride water mains. The majority of the distribution system was constructed in 1947.

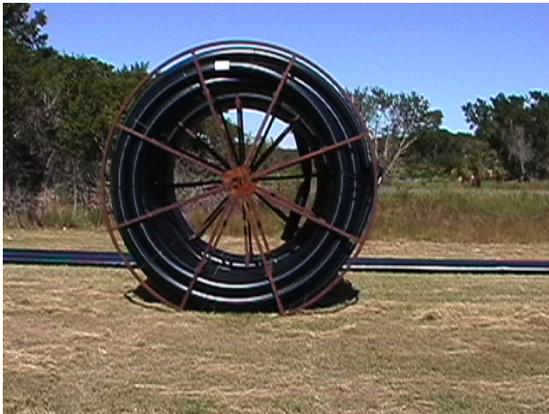
Figure 1: HDPE was delivered to the job site in 4- and 6-inch coils. Each coil contained a continuous piece of pipe.

pipeline (Figures 1 and 2) by the pipe bursting method. The polyethylene pipelines were pre-chlorinated (Figure 3) to disinfect and cleared of bacteria above ground prior to installation. This allowed the new lines to be placed into service immediately with minimal disruption to the visitors and residents at the Park. This project is the largest application to date in total linear footage of this technology in North America.

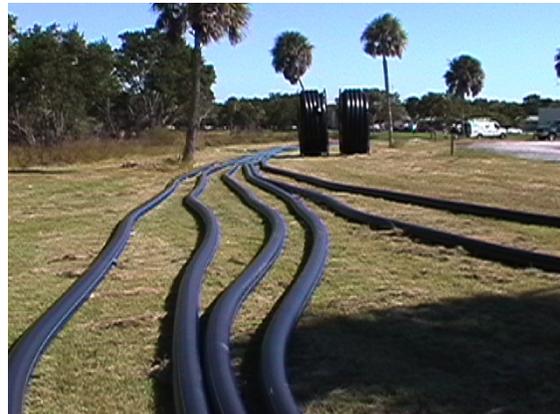
Figure 2: The 8-inch lines were delivered in standard 40-foot sections and butt-fused and assembled in the staging area.

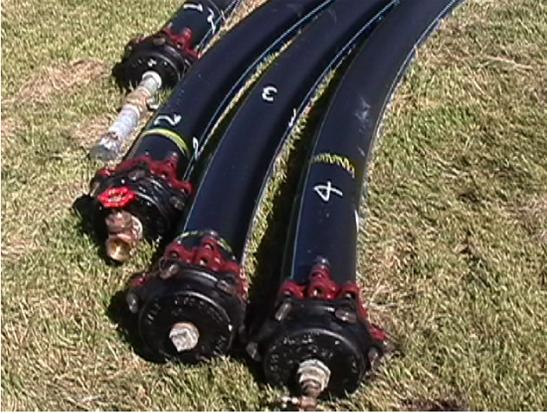
Figure 3: The various lines were capped and disinfected with a hypochlorite solution. The lines were then flushed and 2 consecutive days of samples were drawn from the lines and tested for bacteriological clearance. The lines were then capped again. If the lines passed the bacteriological clearance, the line was prepared for pressure testing.

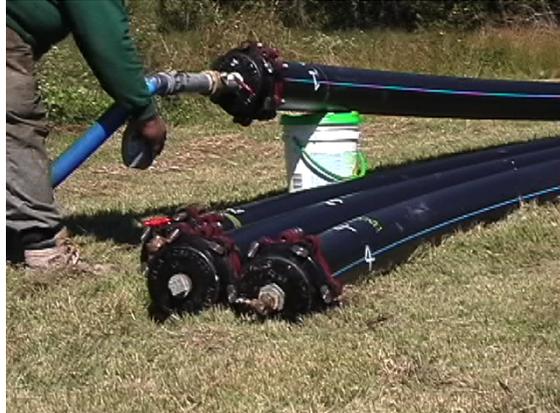
Figure 4: The lines were pressure tested above grade to ensure they contained no leaks.

A major breakthrough occurred when the properties of HDPE were capitalized upon to allow the replacement lines to be disinfected and pressure tested prior to their installation. During the pipe bursting process, a sealed pulling eye or a welded polyethylene puller is utilized to keep the interior of the pipe free from contamination. The properties of HDPE allow it to be fused together into long sections. The fusion welds have strength greater than the walls of the pipe itself. This allows the entire length of the pipe to be fused and assembled in a continuous section or delivered to the jobsite in a continuous coil. Once the pipe is in place, the pipe can be disinfected using a standard practices and pressure tested (Figure 4) to ensure the fusion welds are sound.

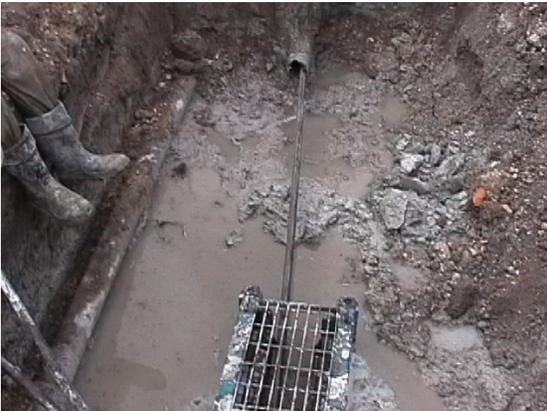
Figure 5: At the entrance pit, a pipe splitter and pipe expander were attached to the threaded rod assembly. The pipe cleared of bacteria and pressure tested, is attached to the end of the splitter, expander train and prepared for insertion behind the bursting tool.

The following sequence of pictures (Figures 5 through 11) depicts the typical construction sequence that occurs to install HDPE water mains utilizing pipe bursting.

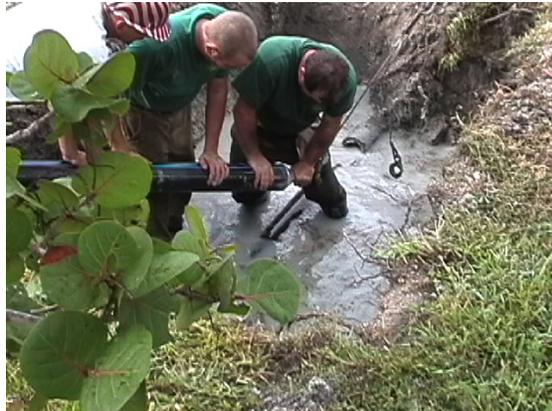
Figure 6: Entry and exit pits were excavated on either side of the line to be replaced. Using a hydraulic ram, a system of threaded rods were inserted into the host pipe from the exit pit side of the host pipe. This process continued until the threaded rods appeared in the entrance pit.

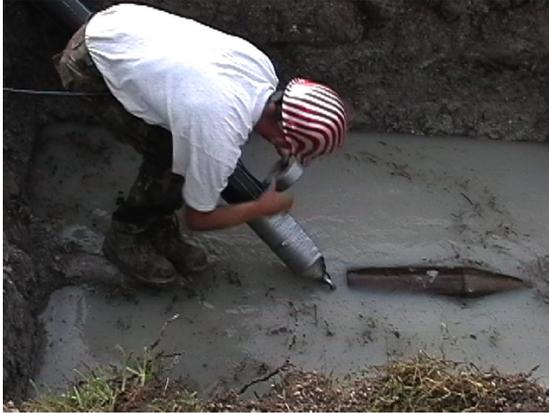
Figure 7: A copper wire was attached to the HDPE pipeline. This tracer wire would be used to locate the line after installation.

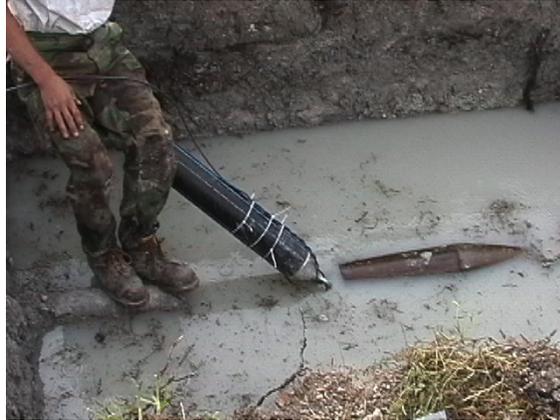
Figure 8: If necessary, the entrance pit was expanded to allow for the HDPE pipe to make a smooth transition into the host pipe.

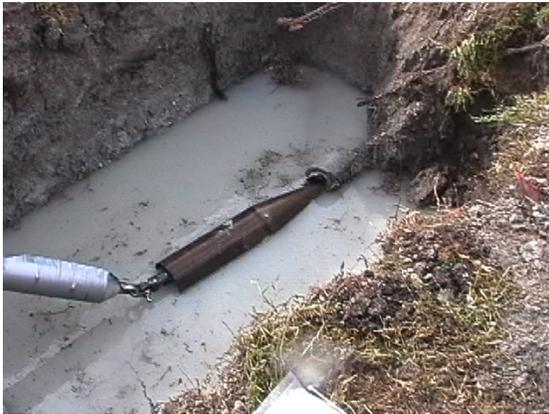
Figure 9: From the exit pit, the hydraulic ram was switched from push to pull. The system of rods was then pulled back through the host pipe. This in turn drew the splitter, expander, and new HDPE back through the host pipe. This pull caused the host pipe first to be split. The pieces of the host pipe would then be pushed into the surrounding soil by the expander. Finally, the new pipe would be pulled through the annular space created by the expander.

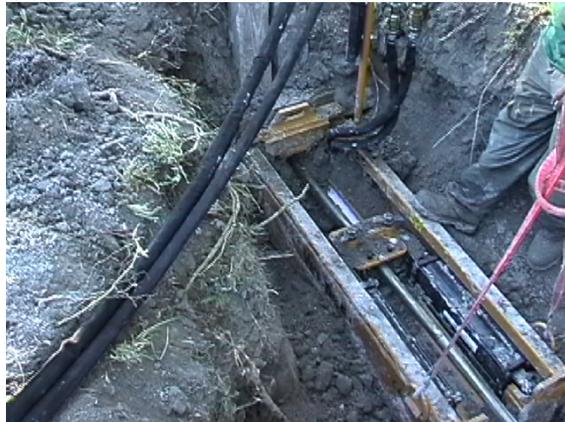
Figure 10: At the exit pit, the sections of threaded rod were removed.

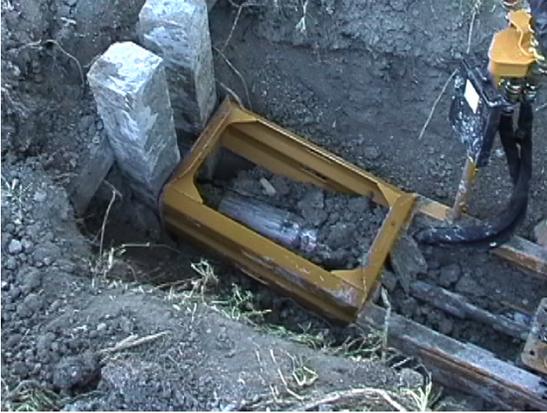
Figure 11: Finally, the new HDPE appeared at the exit pit. The line was connected at the entrance pit and the water services tied into the new line. The process could then continue. The entrance pit was restored and the exit pit became the new entrance pit for the next burst.
