The City of Port St. Lucie's programmatic approach to asbestos cement pipe bursting

Laney Southerly, P.E., Project Planning Engineer, City of Port St. Lucie, Florida; **Edward Alan Ambler**, P.E., LEED AP, Vice President, AM Trenchless, Lake Mary, Florida; and **Todd Grafenaur**, Educational Director, Murphy Pipeline Contractors, Milwaukee, Wisconsin

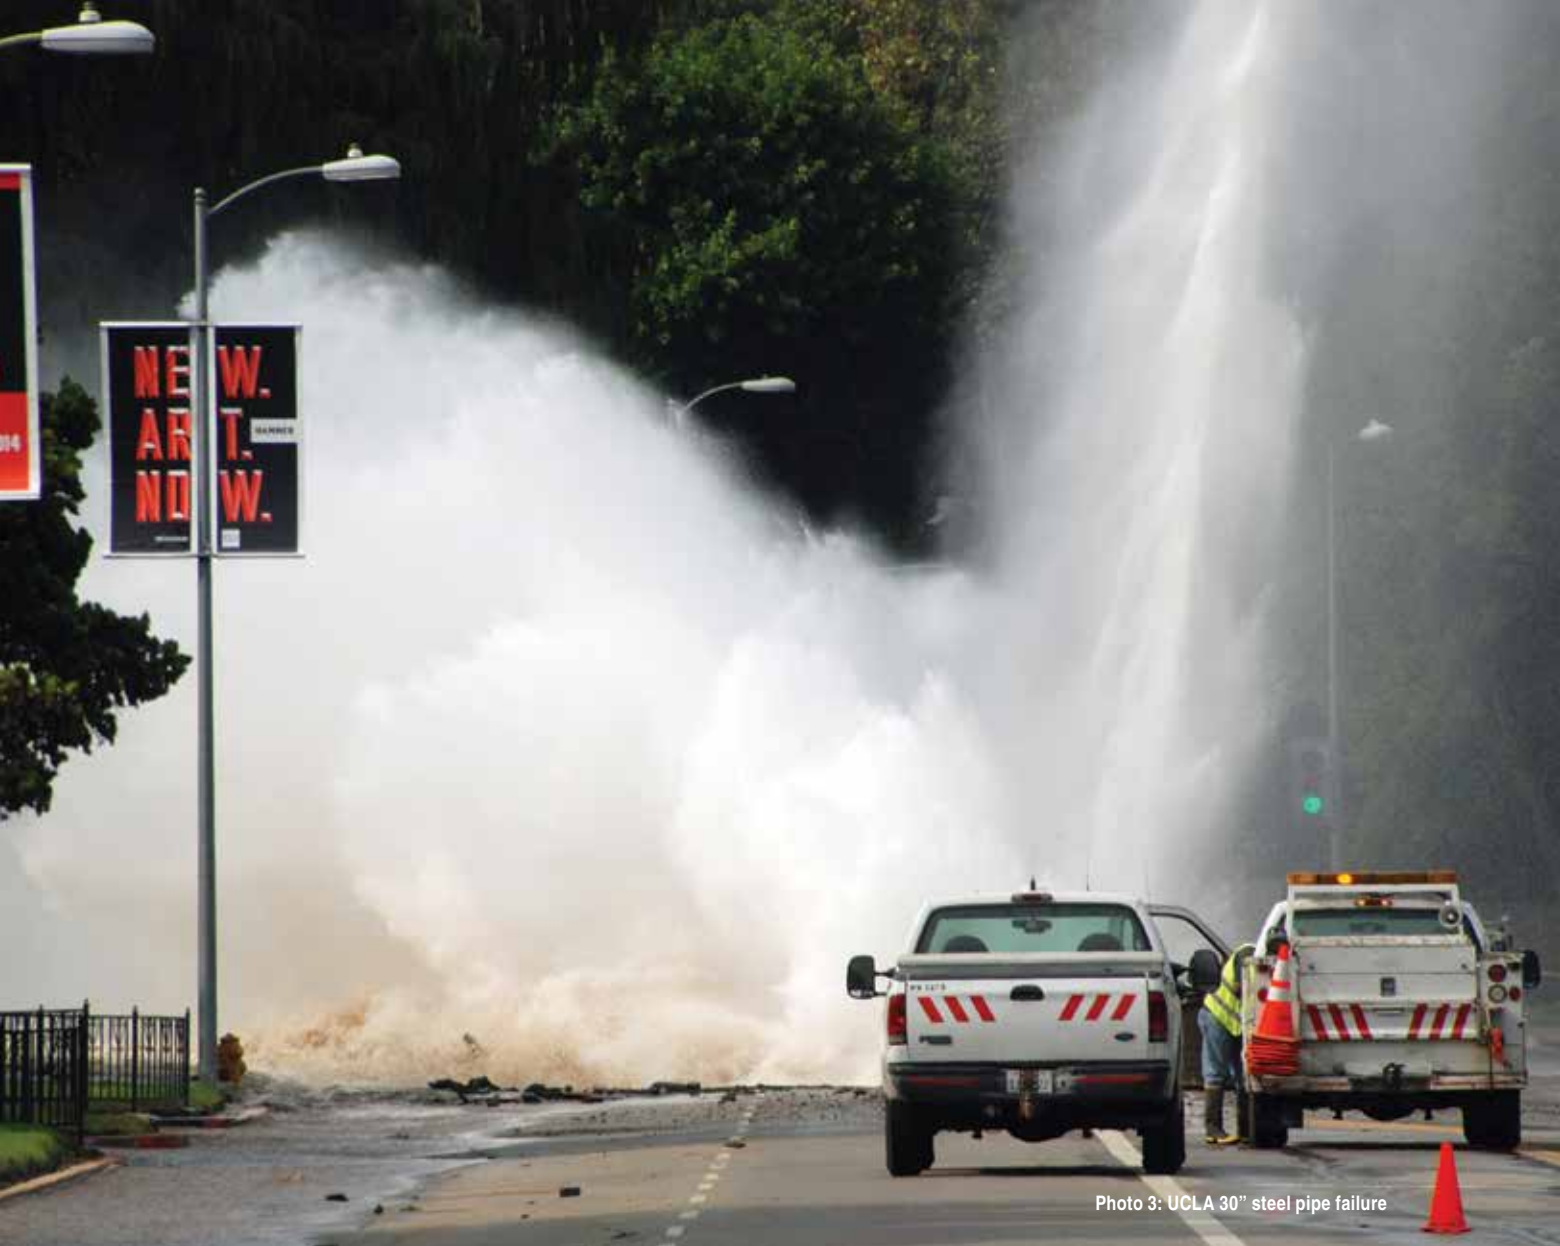
Photo 3: UCLA 30" steel pipe failure

Literature review was conducted in an attempt to analyze the potential social, environmental and economic costs of catastrophic failure. Recent failure of a 93-year-old 30” steel potable water main was evaluated as a potential worse case scenario for the City of Los Angeles (see Photo 3). This failure attracted national news coverage and caused significant environmental, social and economic damage. It took four hours to shut off the main due to inoperable valves. Over 160 firefighters responded to the water main break to search over 200 cars. Flooding from lost water occurred in a

historic basketball court. It was estimated that approximately 48 million gallons of water were released. The overall costs of failure are estimated in the table on p. 110. (Piratla, 2015).

UCLA Catastrophic Failure Example Analysis

Date	July 2014
Pipe Size/Material	30" Steel
Pipeline Operating Pressure	200 psi
Time required to isolate water main	4 hours
Water loss	48 Million Gallons
Hours to complete repair	238 hours
Total Cost	\$36.1 Million
Total Cost per linear foot	\$481,333
